Civil Engineering Journal

Vol. 6, No. 4, April, 2020

Healing of Generated Cracks in Cement Mortar Using MICP

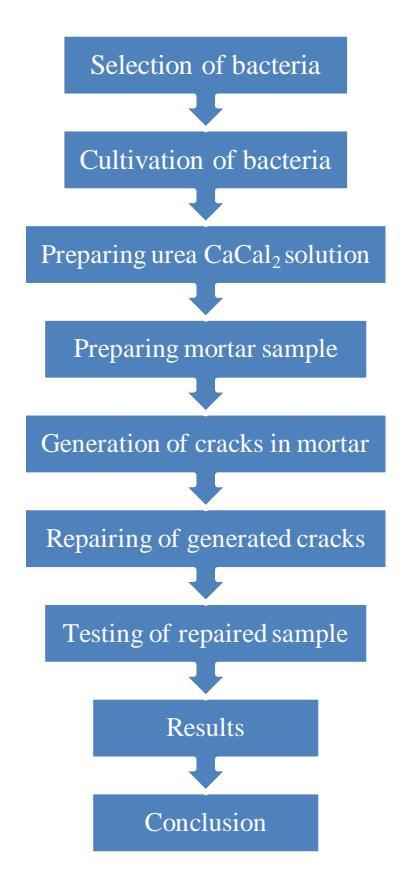
Figure 1. Represent flow diagram of the overall process followed

Figure 1 represent the basic flowchart which gives detail information about the selection of bacteria and its cultivation of culture. Preparation of desired molarity cementation solution of $Cacl_2$ using standard OPC cement, locally available sand with desired water cement ratio. Cement mortar was prepared by using this mixture. Artificial cracks were generated as mentioned in section 2.2. and followed by MICP treatment. The repaired sample were tested for permeability and spilt tensile test using standard methods.

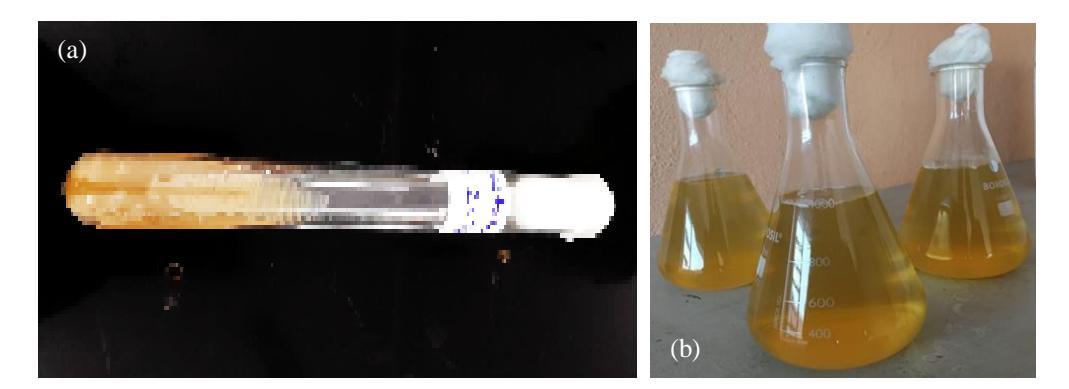
Figure 2. (a) Bacterial culture; (b) Cultivation of culture (microorganism)

Due to the high urease activity of *Bacillus pasteurii or Sporosarcinapasteurii*, these microbes are extensively preferred to produce a high amount of precipitates within a short period of time [18]. Bacterial culture of *Bacillus Pasteurii NCIM 2477* shown in Figure 2(a) was collected from the National Collection of Industrial Microorganism, Pune, Maharashtra (India). *Bacillus Pasteurii* is cultivated in the laboratory using nutrient agar media with protocol and instruction mentioned on the container of culture medium. 20 grams of agar and four grams of nutrient agar powder were mixed well in 250 ml distilled water and the pH was adjusted between 7 to 7.5. The Nutrient agar solution was then heated up to boiling point 100°C using the heater. The autoclave was used for sterilization of nutrient solution and other glassware. Figure 2(b) shows the Cultivation of culture.

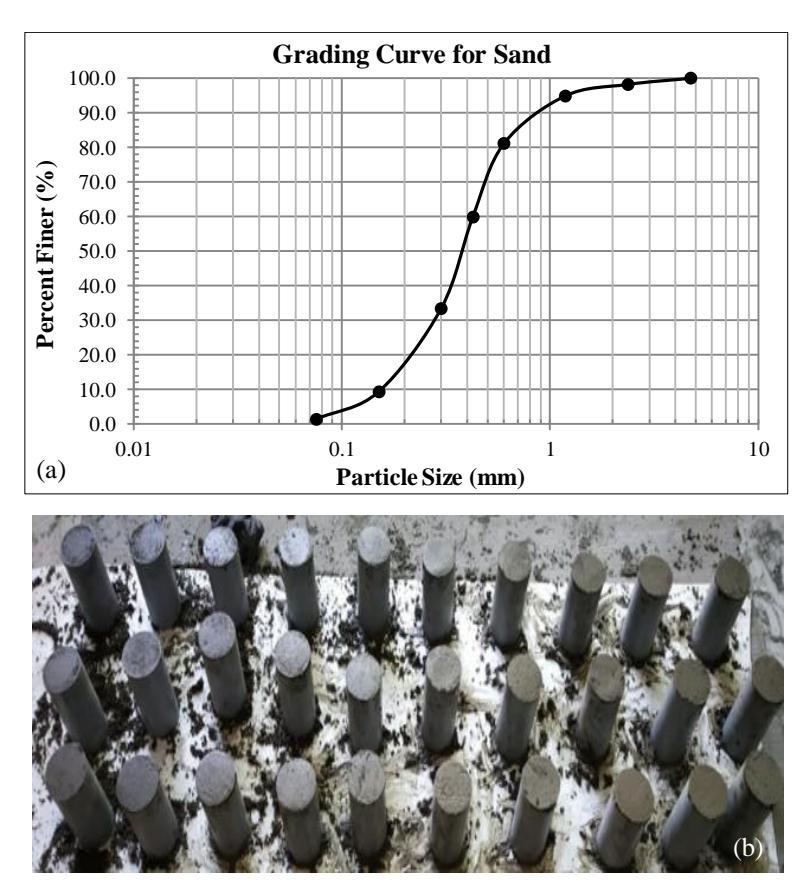
Figure 3. (a) Prepared mortar samples; (b) Grading Curve

Type I ordinary Portland cement (OPC) of 53 grade, river sand, and distilled water were used to prepare mortar. Figure 3a illustrates the grading curve of sand used. The cement had a specific gravity of 3.12, normal consistency 29%, bulk density 1400 Kg/m³ and Blaine fineness 330 m²/kg. The sand had a specific gravity of 2.68 and a fineness modulus of 2.62 and density 1600 Kg/m³. The water-to-cement (w/c) ratio was 0.4 and the sand-to-cement (s/c) ratio was 3.0. To prepare a homogeneous mix of the mortar, the cement was first added into water and mixed by hand for 2 min followed by sand mixing for another 2 min. Thin plastic pipes (45 mm in diameter and 90 mm in height) were used for casting. Two half rods of 10 mm diameter and 90 mm length were placed in molds to ensure single and straight crack in the sample. The freshly mixed mortar was poured into these molds as shown in Figure 3b, in two layers, and each layer of all samples was compacted to the equal desired density. After casting, the mortar samples were sealed and placed in a lab environment (24 to 26° C) for 28 days for curing. At the age of 28 days, three virgin samples (ST1, ST2, ST3) were tested for split tensile strength according to IS-5816-1999 and the rest cylinder samples were cut to develop/gain different crack sizes and then to perform crack repair.

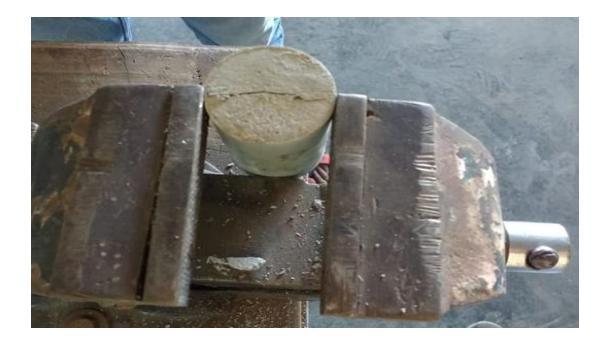
Figure 4. Crack generation

In the process of generation of artificial cracks of different sizes in all 10 mortar samples, end portions were trimmed by 10 mm and the middle 80 mm was cut in equal two half with their plastic molds on, each of 45 mm diameter and 40 mm in length. These, 20 short discs samples were split to have different crack widths using a jaw clamp as shown in Figure 4. A sample crack generated is shown in Figure 5. A small clamping arrangement was made to keep crack open, and photographs of both end cross-section were taken. At the end of 28 days, small clamps were removed, and crack repair work was initiated.

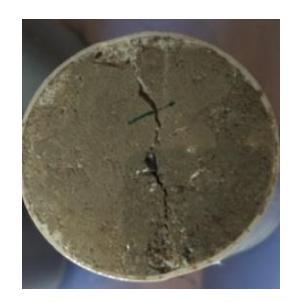
Figure 5. Camera picture

Figures 5 and 6 show a photograph and the features received through CAD respectively for a few samples. A photography examination was done to understand the size and pattern of cracks generated. The photo images were then inputted to (CAD) to characterize the crack features and compute crack areas and widths. For a correct representation of crack width and to account for irregularity of cracks at two ends of the disc, the average crack size of the two ends was used and further calculation was made using the Equations 3 and 4.

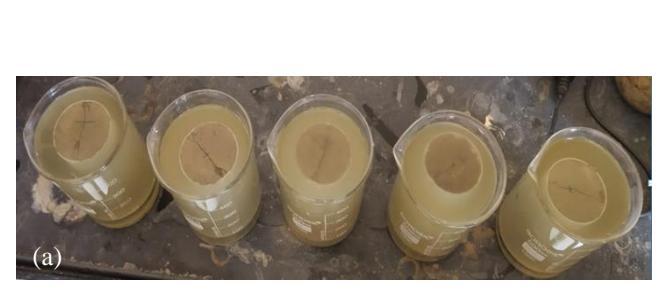
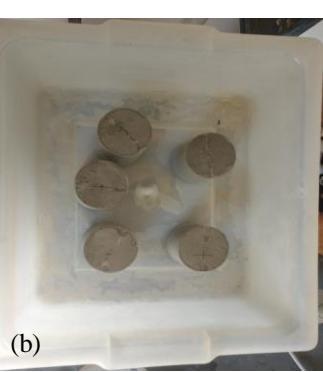
Figure 7. Soaking of samples

(a) Bacterial solution

(b) Cementation solution

MICP treatment for sixteen samples was performed in bacterium solution and urea-CaCl₂ solution at room temperature $30 \pm 2^{\circ}$ C. Each cracked sample was soaked in bacterium solution for 2 hours as shown in Figure 7(a) and allowed the samples to saturate. After taking out from the bacterium solution, samples were made to drain off. Then all these samples were put in a container having urea-CaCl₂ cementation solution as shown in Figure 7(b) hours for the MICP process to happen. These 24 hours is counted as one round of treatment. The whole assembly of the sample with cementation solution was kept circulating with the help of a plate and stirrer bar. Repeat all these steps for the next 8, 16, 24 rounds of the treatment.

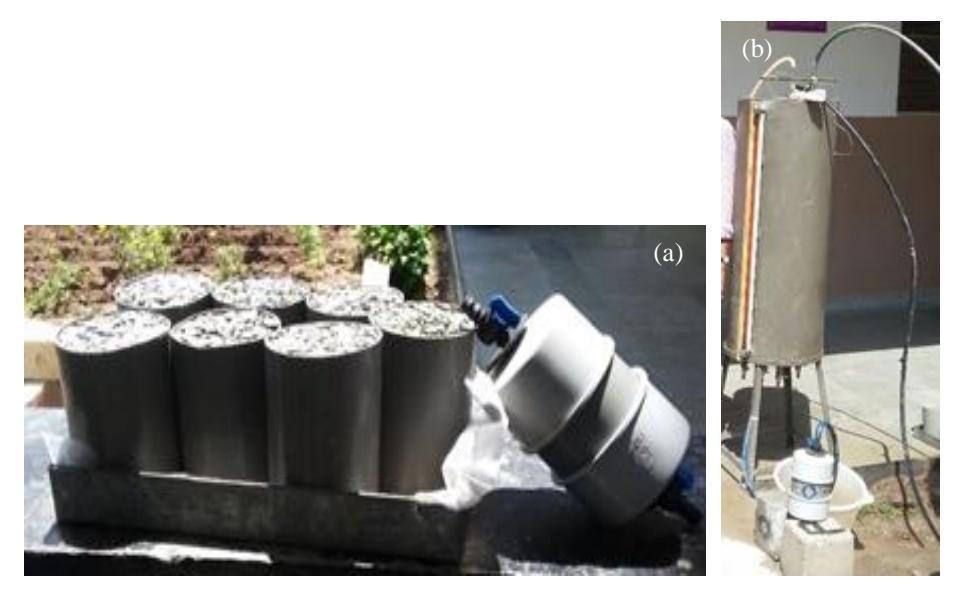
Figure 8. (a) Permeability sample mould; (b) Experimental setup for permeability test

Permeability test on all sixteen samples was conducted using the constant head method as per IS-2720 (Part17)1986 to find the efficacy of repair using MICP treatment and curing period concerning crack width. All samples were soaked in water for 24 hours for saturation before conducting the permeability test. A sample of 45 mm diameter and 40 mm length was trimmed at the end to just fit at bottom of transparent graduated glass pipe of 45 mm diameter, 150 mm height. The proper arrangement was made to seal the joints of the pipe and specimen. This assembly of permeability mould as shown in Figure 8(a) and experimental set up shown in Figure 8(b). Tap water was continuously filled in a glass pipe to maintain a constant head with a proper outlet for overflow. The volume of water flowing out from the container and corresponding time was recorded to calculate the coefficient of permeability k using the formula mentioned in Equation 5.

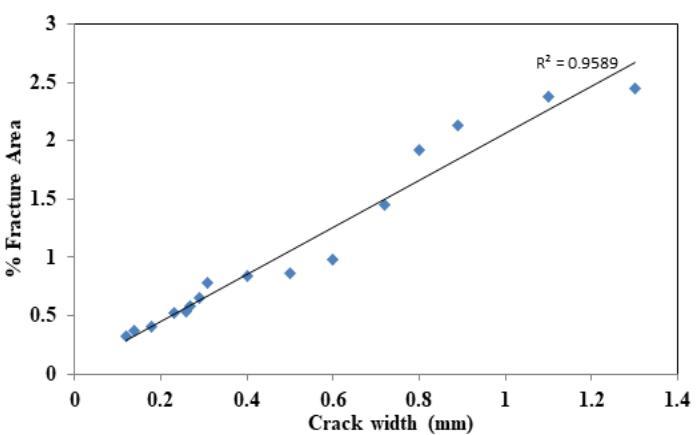
Figure 9. Generated crack width Vs % fracture area of mortar sample

Permeability test on all sixteen samples was conducted using the constant head method as per IS2720-1986 (Part17) to find the efficacy of repair using MICP treatment and curing period concerning crack width. All samples were soaked in water for 24 hours; the results obtained for sixteen MICP treated samples through permeability, STS and percent of precipitated $CaCO_3$ are summarized in Table 1. Table 2 depicts the results of permeability on four untreated samples. Figure 9 illustrate the linear relation of crack width generated and percent of fractured area. Figure 9, illustrate that crack width is directly proportional to percent of fractured area. Figure 9 satisfies strong linear association among the crack width and fractured area.

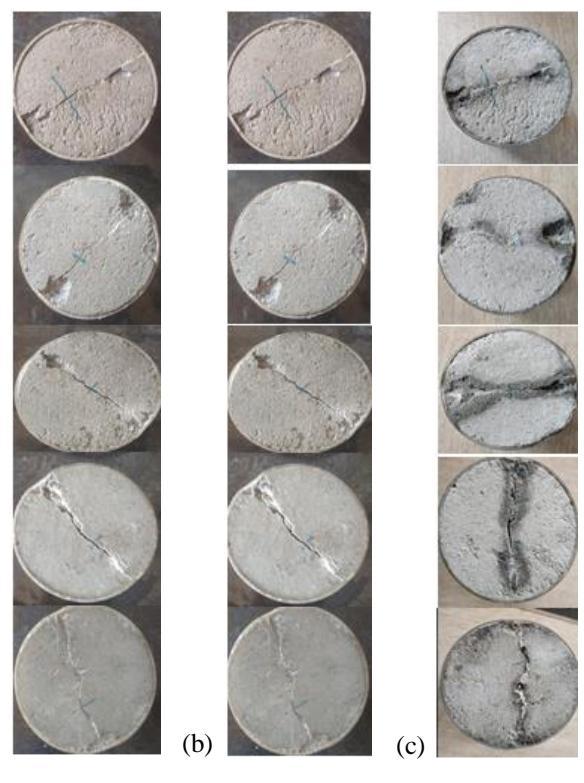
Figure 10. Cracks repairs at different rounds of MICP treatments. (a) At 8th round; (b) At 16th round; (c) At 24th round

Progress of crack healing at different rounds for the representative sample is shown in Figure 10. It is observed from Figure 10, that due to MICP treatment, cracks are gradually healed over the number of treatment round. Healing of cracks varies with the percent of precipitation of CaCO₃. Smaller cracks get healed at earlier round. It is to note that internal cracks could not get repaired 100% in spite of precipitation of CaCO₃ on the cracked surface was 82.34 rather than 100%. Also, negligible healing of crack is observed in samples (UTC1 to UTC4) which are untreated (soaked in water only). Similar report has been mentioned by author Chen et al. (2019) [20] that MICP can effectively use for healing of crack due to deposition of calcium carbonate deposition.

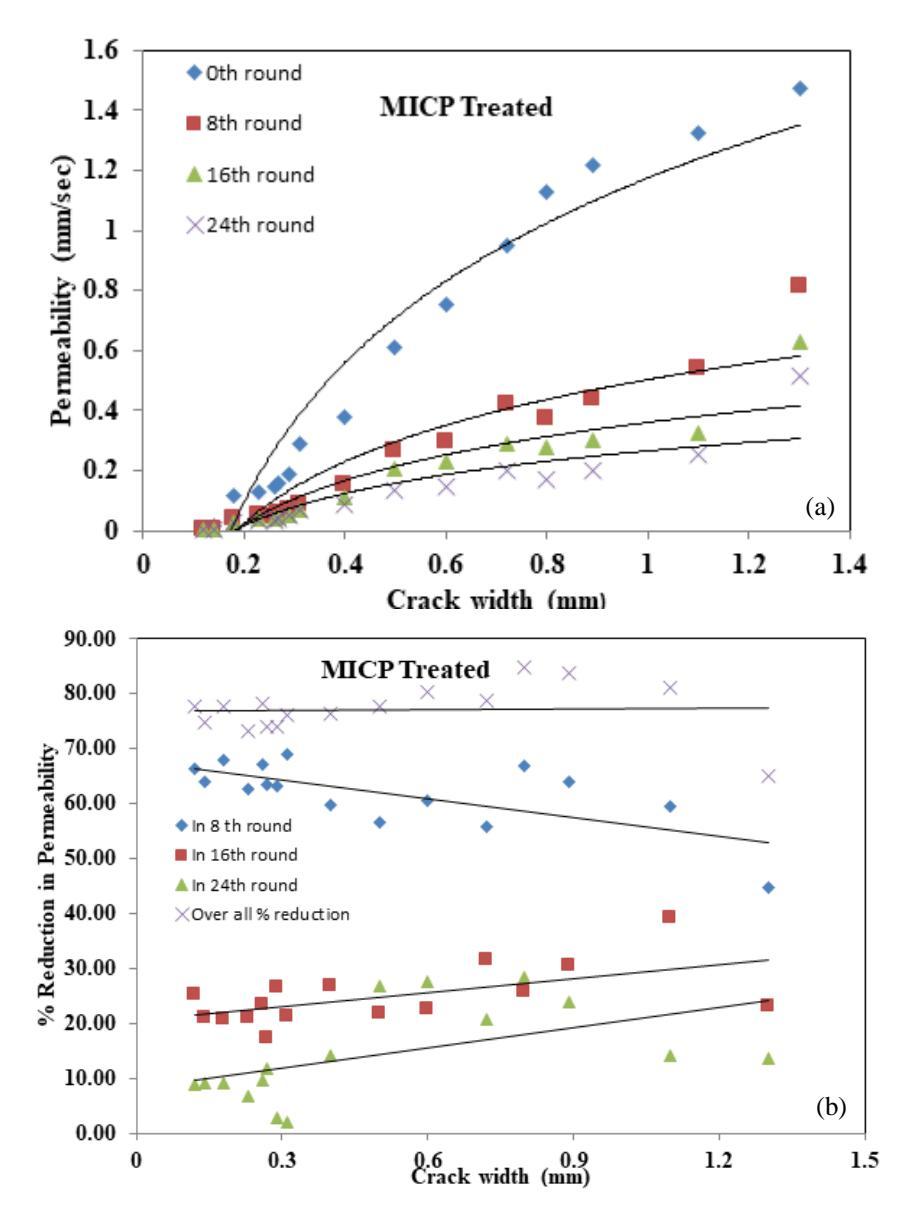
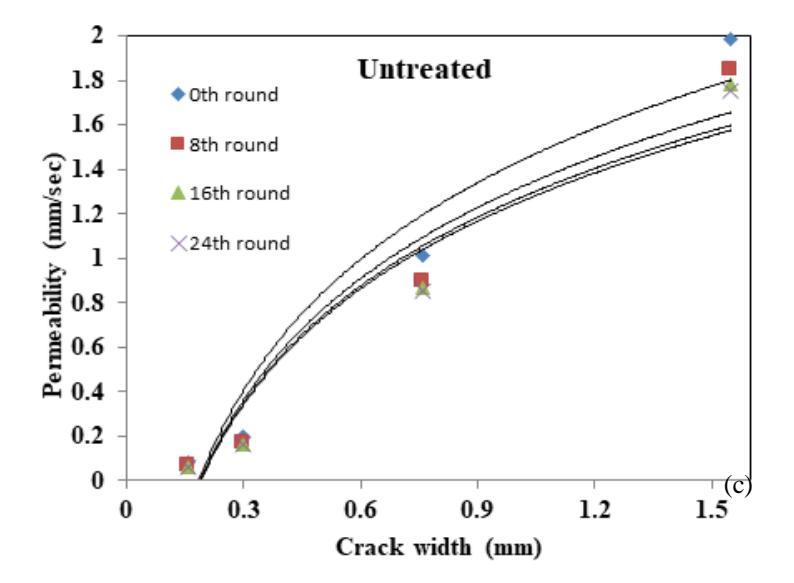
Figure 11. (a) Repaired specimens using MICP treatment (b) % reduction in permeability (c) Permeability results for untreated specimens (soaked in water only)

Figure 11(a) and 11(b) and Tables 1 and 2 represent crack repairing performance of MICP treated and untreated mortar samples on permeability respectively. Increase in permeability with an increase in average crack width, as seen in Figure 11(a). As crack width increases from 0.12 mm to 1.3 mm, permeability has increased from 0.008335 mm/sec to 1.4721 mm/sec. The authors are of opinion that results obtained are in line with Tittelboom et al. (2010) [1] in which the average crack width of the split cylinder increased from 0.15 to 0.30 has resulted in an increase in permeability from 0.05 mm/sec to 0.5 mm/sec. In the present study crack width ranges from 0.12 to 1.3 mm. The slope of (permeability vs crack width, Figure 11(a) curve is steeper for 0th round in comparison with the 24th round of MICP. Also, Figure 11(b) depicts an average 60% reduction in permeability of all cracked samples at end of 8th round after MICP treatment. The however smaller rate of reduction in permeability was observed at the end of 16th (25%) and 24th (14%) round respectively. This point out the percent of healing of cracks is faster up to 8th round and it slows down thereafter. This could happen because of the amount and dissemination of CaCO₃ in the cracks which have reduced permeability. At the end of the 24th round, the maximum reduction was in the range 73 to 85% as that of 0th round, indicating, 100% reduction in permeability could not be achieved because of the non-healing of all cracks.

Figure 11 represents crack repairing performance of untreated (soaked in water only) mortar samples on permeability. The decrease in permeability up to 25% for the sample (UTC1) with fine 0.16 mm average crack width, from 0.08053 mm/sec at 0th round to 0.06013 mm/sec at 24th round could be the result of autogenous healing due to hydration of cement [18]. As anticipated for sample (UTC4) with a major crack of 1.55 mm, reduction in permeability on account of autogenous healing due to hydration of cement was negligible (11%).

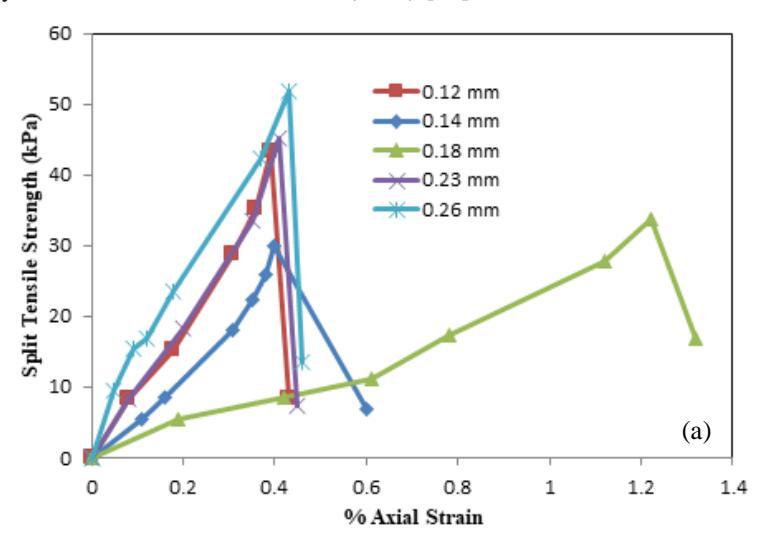
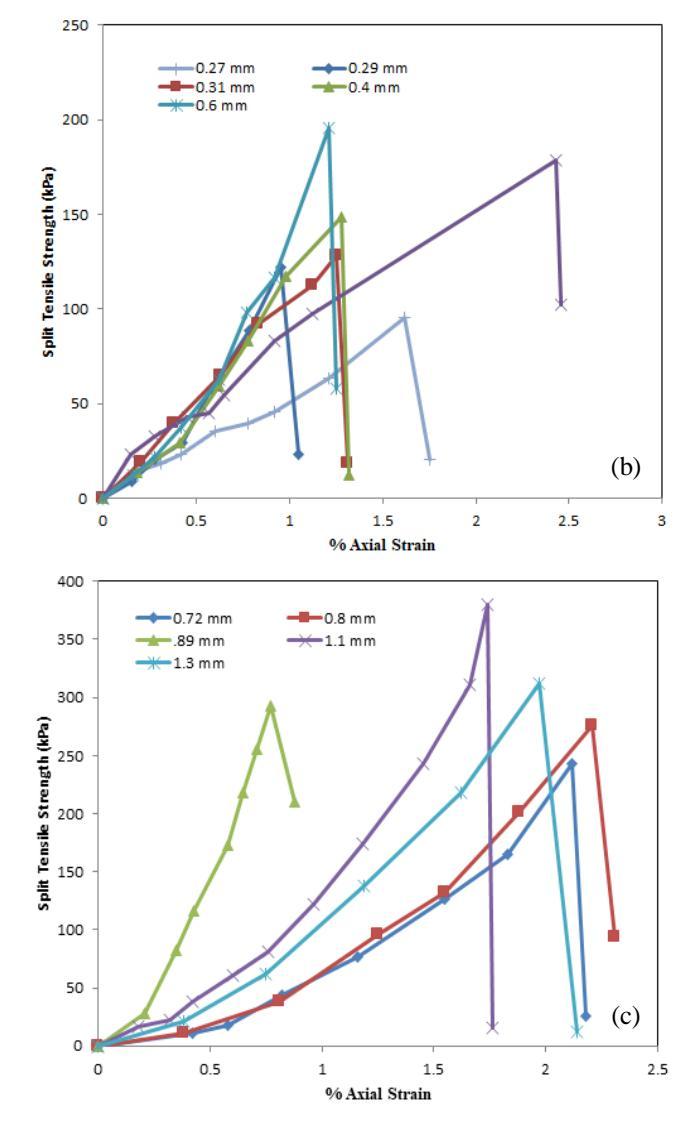
Figure 12. (a) Crack width from 0.12-0.26 mm; (b) Crack width from 0.27-0.6 mm; (c) Crack width from 0.72-1.1 mm

The results of STS conducted on three virgin samples (ST1, ST2, ST3) at the age of 28 days, was 3674 ± 126 kPa. This test was also conducted on MICP treated samples (TC1 to TC16) at the end of the 24^{th} round. However, the test could not be possible on the untreated sample (UTC1 to UTC4) as it fails immediately on the application of negligible load. This could be because of insufficient binding developed due to the autogenous healing of cracks. The results obtained from the split tension test on TC1 to TC16 samples are shown in Figure 12. Based on these following findings are noted.

Figures 12(a) to 12(c) STS vs strain curves for repaired specimens with different crack widths. Figure 13 (a), depicts the graphical presentation of the amount of $CaCO_3$ precipitated Vs. crack width. A peanut swing from 4.12 to 7.19% in calcium carbonate deposition is seen in a region I, where crack width is less than 0.27 mm. This could be due to minimal entry of bacteria or cementation solution in small cracks followed by 15 to 20% increase in CaCO₃ in region II of crack width 0.29 to 0.6 mm. Substantial increases in region III (52 to 82%) imply that the favorable crack width for repair through MICP is 0.72 to 1.1 mm. For region IV for 1.3 mm crack, an unexpected slight decrease in CaCO₃ may due to unidentified reasons.

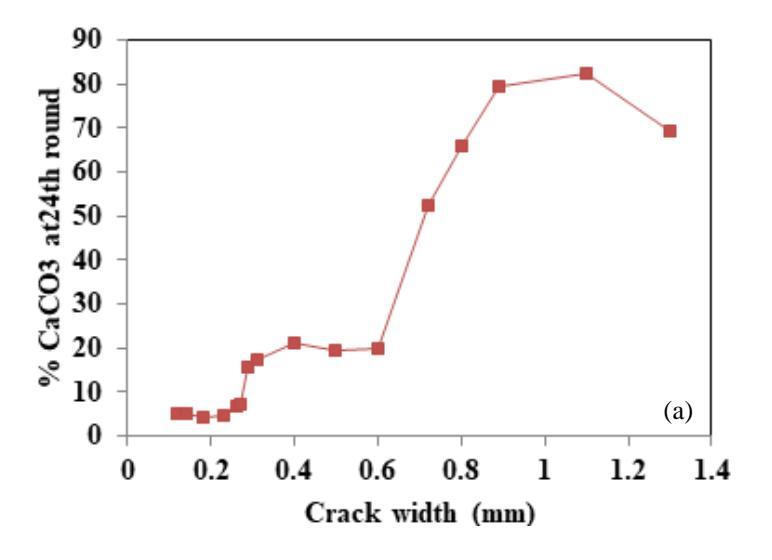
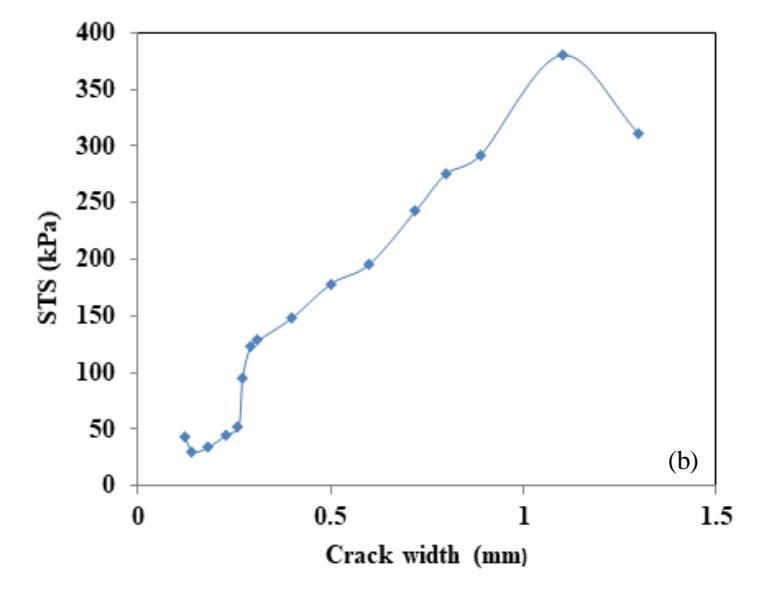
Figure 13. (a) Crack width % vs. CaCO₃: (b) Crack width vs. STS

The relationship between STS and crack width as shown in Figure 13(b) indicates that in the region I for crack width less than 0.29 mm, there is no clear co-relation. This could be because of quick sealing of small cracks might have stopped the entry of bacteria and cementation solution resulting in lower values of STS. Exactly reverse of this is observed in the region III, despite large crack width (1.3mm), STS has decreased (311 kPa) over prior values (380 kPa). One of the causes could be insufficient sticking/formation of the bond between cracks and smaller size and microstructure of distribution of CaCO₃. This indicates from region II that, 0.31 to 1.1 mm crack width sizes in mortar can be effectively repaired by MICP.
