# GREEN AUDIT REPORT

## 2023-2024

**Dr. Vithalrao Vikhe Patil College of Engineering,**  
Ahmednagar

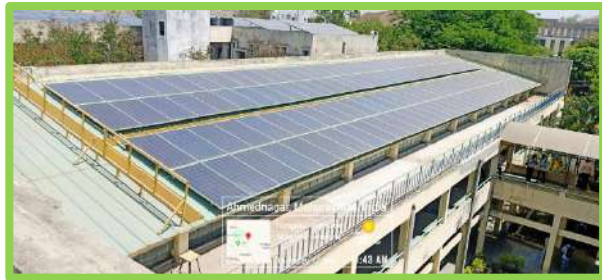
Figure 2: Solar Plant

The captive solar generation plant is capable of generating annually 4,59,000 Kwh units which caters for Ninety-five percent (95%) of our annual consumption. The plant is state of the art IoT enabled generation plant giving real time generation and fault status on line.

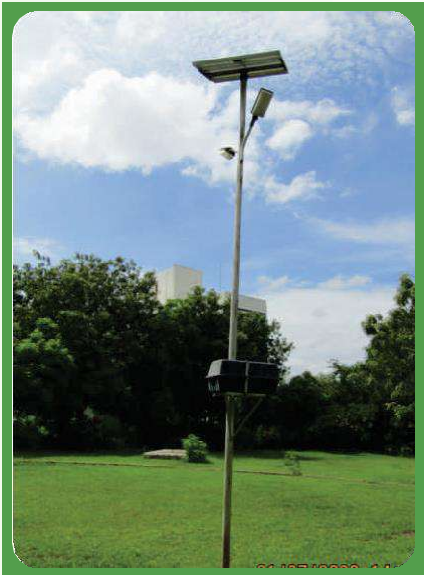
Figure 5 : Estimation of annual solar energy generation

Capacity Factor	17.5%
-----------------	-------

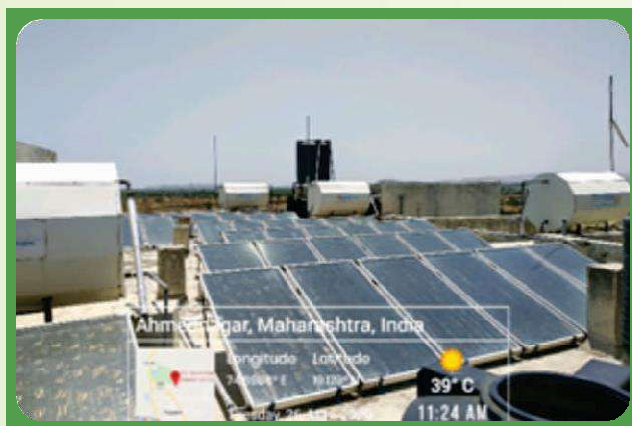
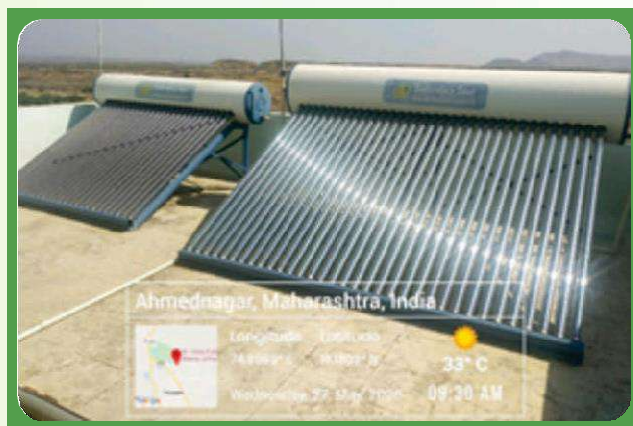
<i>Solar Water Heating Provisions in the campus</i>	
<b>Building</b>	<b>Solar water heating provision (LPD)</b>
Kaveri Hostel	3000
Hostel A	2000
Hostel B	2000
Staff quarters	1000

Figure 7 : ETC and FPC solar water heating system

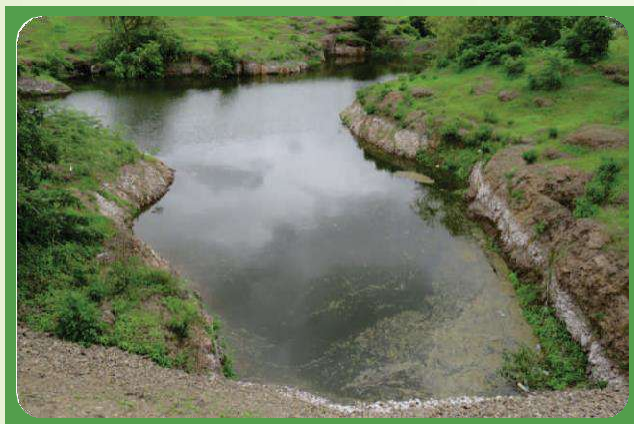
Figure 8 : Check Dam No. 1

The rainwater from roof tops and paved areas are conveyed to check dams through storm water drains. Check dams are located as per contours at intervals. The water in the check dams percolates and helps in increasing ground water levels. The natural water flows and slopes on site are maintained.

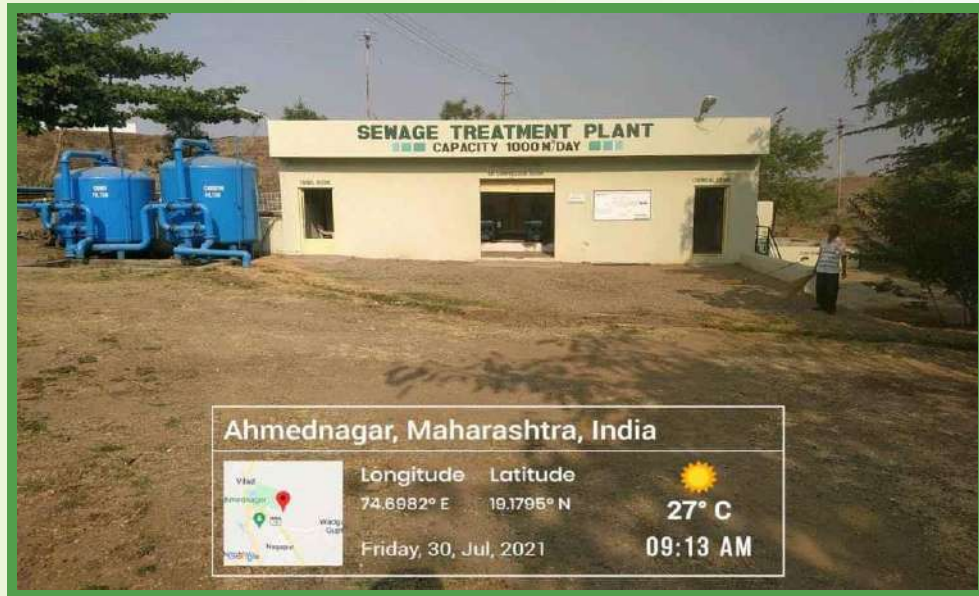
Figure 13 : Sewage Treatment Plant

The project has a 1000 cum /day capacity sewage treatment plant on site. It is a Moving Bed Biofilm Reactor (MBBR) waste water treatment plant. It is a biological technology suitable for high volume load. (Refer Annexure 4). The process flow diagram of the system is elaborated in Figure 11.

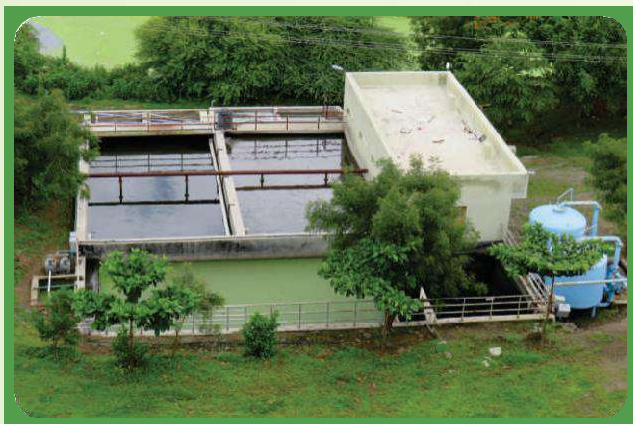
Figure 14 : On-site STP

The project reuses treated water for landscape irrigation purpose. The irrigated landscape area is around 9500sqm. The water requirement of the landscape area is met by treated water from the STP, thus reducing the use of fresh water. (Refer Annexure 5)

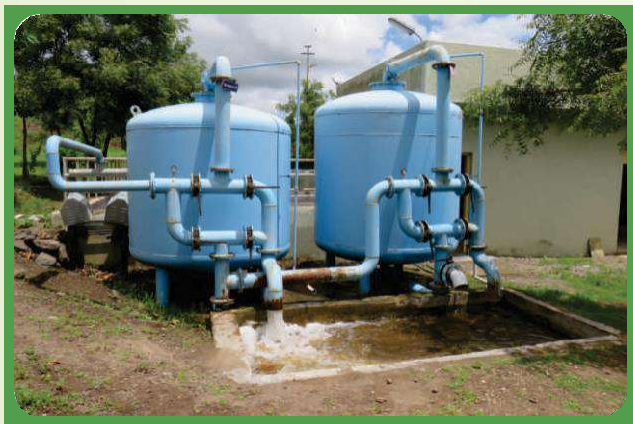
Figure 16 : STP filters and air compressor

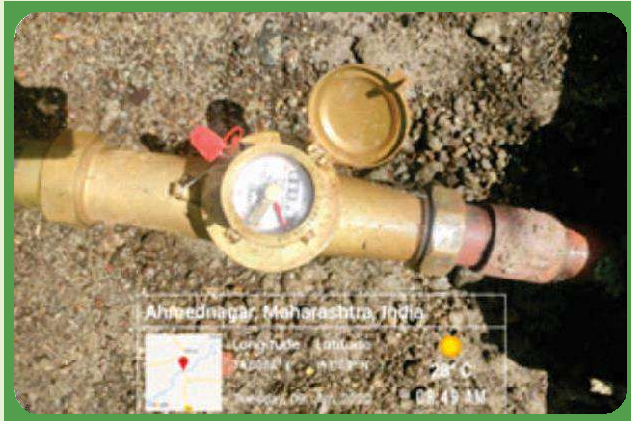
Water metering ensures measurement of water consumption for various water use applications. Building level water meters provide total water consumption whereas if sub meters are installed for applications such as treated water reuse for landscape irrigation, flushing, and domestic water can be measured and monitored. The project has installed source level water meters.

Figure 17 : Water meters installed in campus

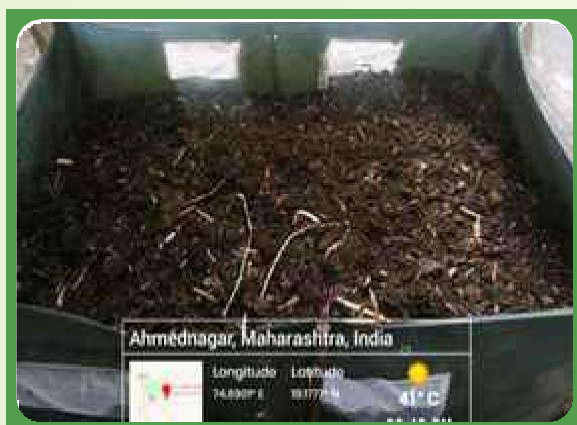
Figure 23 : Generated Compost for Landscaping

No	Parameters	Results	Unit
<b>A) Physical Characteristics</b>			
1.	Moisture	49.20	%
2.	Particle Size	92.35 % passes through 4mm sieve	
<b>B) Chemical Characteristics</b>			
1.	pH	06.71	-
2.	Ec	04.26	mmhos/cm
3.	Colour	Brownish black	-
4.	Total Organic Carbon	30.81	%
5.	Total Organic Matter	53.00	%
6.	C: N Ratio	11.00	-
<b>C) Fertilizer Value</b>			
1.	Nitrogen	2.80	%
2.	Phosphorus	2.53	%
3.	Potassium	0.65	%
4.	Sulfur	0.96	%
5.	Calcium	4.48	%
6.	Magnesium	0.94	%
7.	Ferrous	12598.90	mg/Kg
8.	Manganese	344.60	mg/Kg
9.	Copper	128.41	mg/Kg
10.	Zinc	223.06	mg/Kg

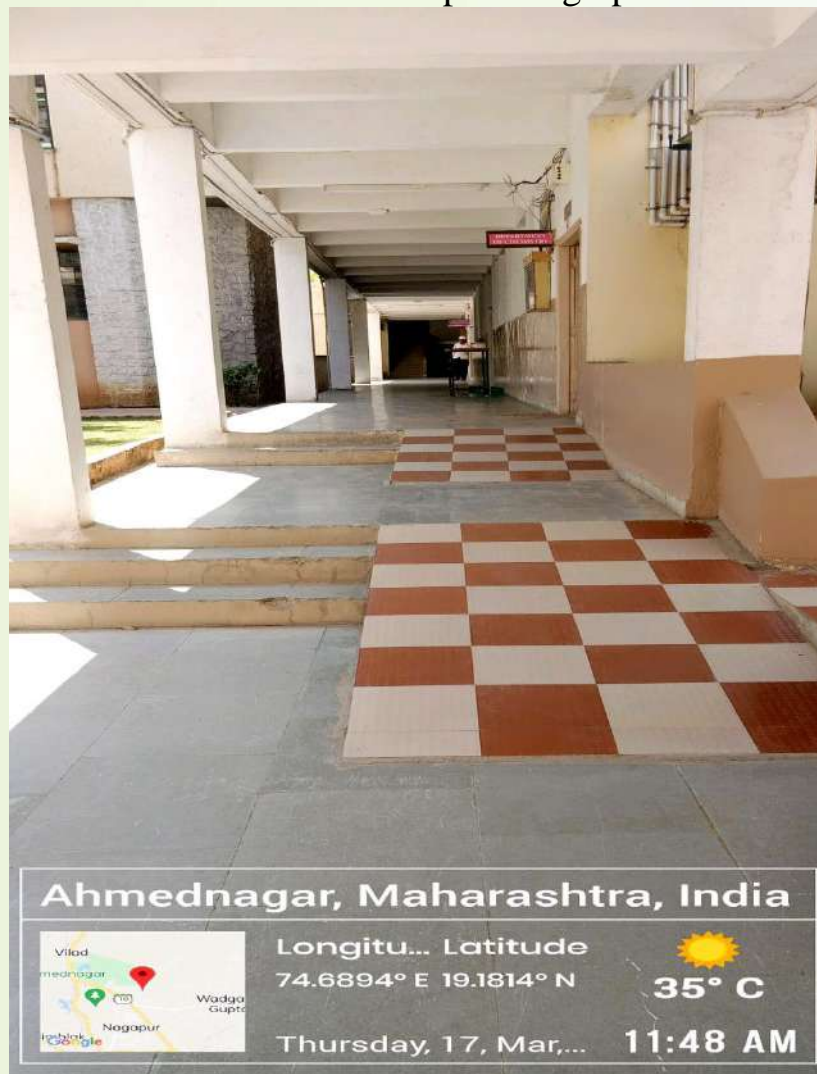
Figure 26 : Images showing entry ramps and handrails along with signage

The project being a hospital and medical college, accessibility is an important aspect. Considering the use of stretchers, trolleys, wheelchairs, etc, the project has provided hindrance free movement by providing ramps, lifts, general signage, accessible toilet etc.

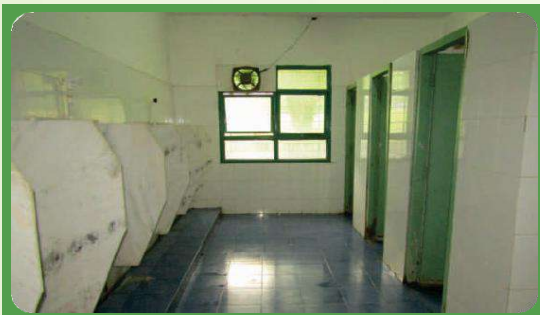
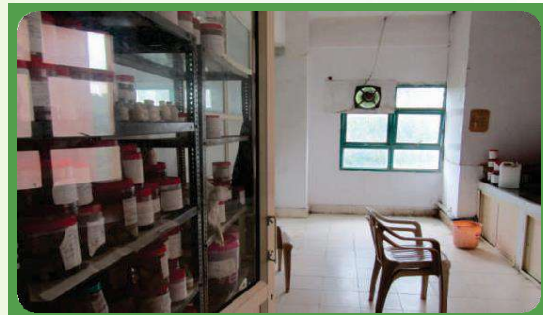
Figure 31 : Exhaust fans in toilet and store

In places where natural ventilation is not sufficient for providing adequate air changes, mechanical ventilation is provided. The exhaust fans helps in venting the spaces such toilets, kitchen, pantry, labs, chemical storage rooms, etc.

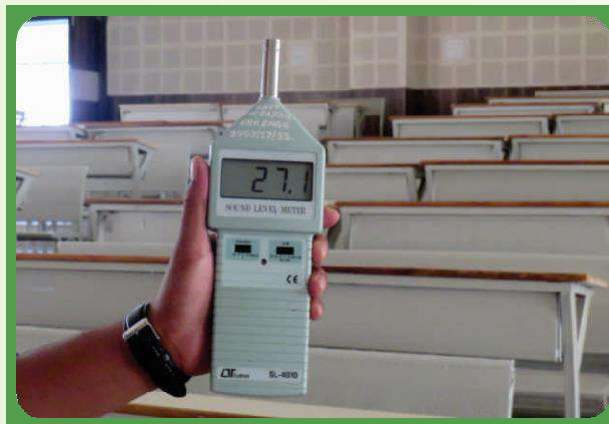
For the project, a decibel meter is used to measure noise levels in different areas within the campus wherein it ranges from 38 dB to 69 dB. It has been found that as the campus is full of green cover and landscaped areas, only the area abutting the highway has higher noise levels. The landscape acts as a noise buffer which keeps the noise at lower levels.

*Figure 32 : Noise level measurement*

6. It is recommended to conduct air quality and noise monitoring as per recommended protocols by Central Pollution Control Board (CPCB).
7. Exhibit posters / signages / green practice guidelines in strategic locations within campus to educate and spread awareness about implemented green campus initiatives to the occupants and visitors.

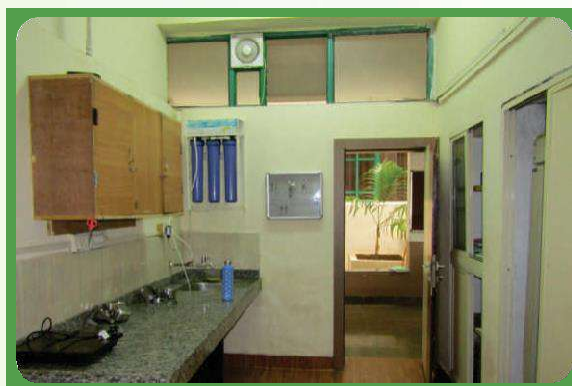
Figure 34 : Drinking water facility

Adequate drinking water facilities are provided in various building blocks. Potable water of requisite quality is being provided and regular tests are carried out. Drinking water quality report is annexed as Annexure 3 Drinking water test report.

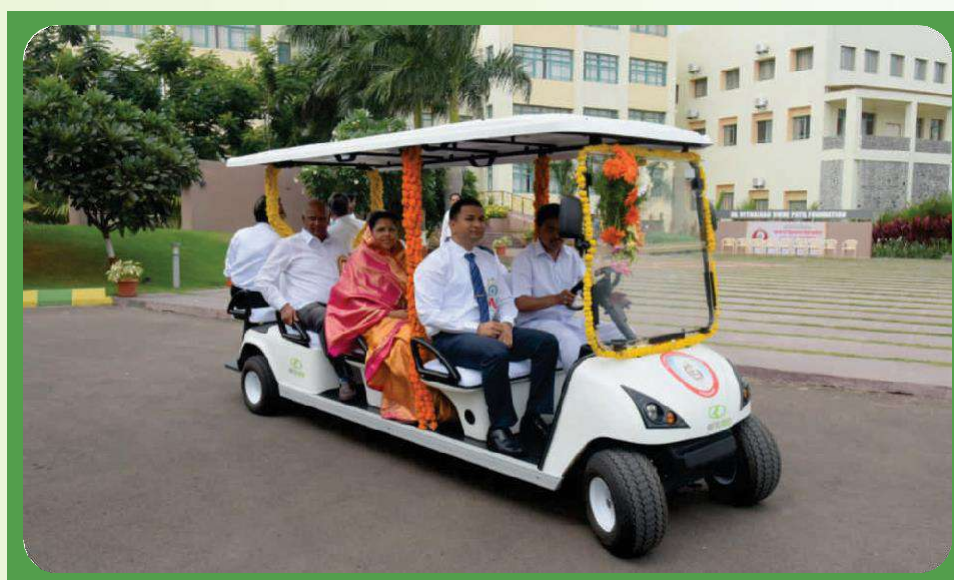
Figure 38 : Battery operated vehicle in campus 'KG- 6+2'

Battery Operated Vehicles		
Technical Specifications	KG-2, KG-2+2	KG-4, KG-6, KG- 6+2
Passenger Capacity	2/4	4/6/8
Frame/Chassis	Steel	Steel
Controller	American Curtis Electronics Controller	American Curtis Electronics Controller
Accelerator	Adjustable Inductive Accelerator Continuously Variable Speed System	Adjustable Inductive Accelerator Continuously Variable Speed System
Charger	Full Automatic Efficiency Pulse Charger	Full Automatic Efficiency Pulse Charger
Slope Climbing Capacity	30%	30%
Power of Motor	3 kW DC Motor	4kW DC Motor
Batteries	8V170AH*6	8V170AH*6
Max. loading weight	360 Kg	560kg/640kg
Range	80-100 km	80-100km
Max. Speed	24 km/hr	24 km/hr

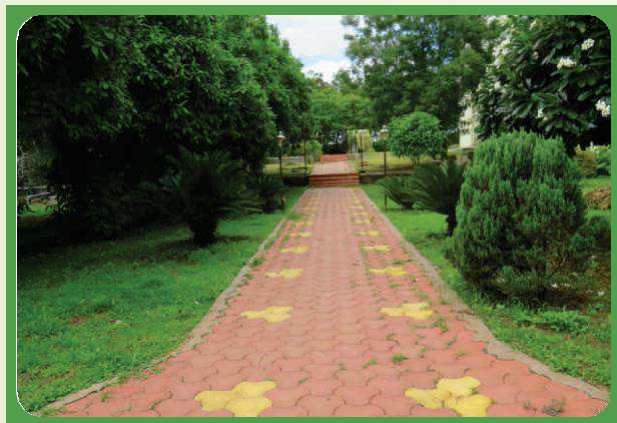
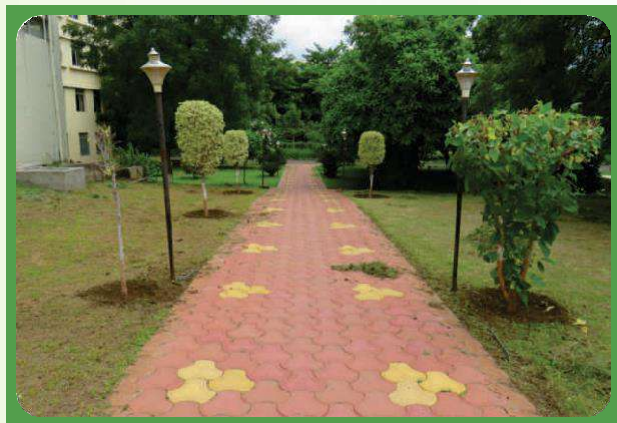
*Figure 39 : Images showing shaded pedestrian pathways in the campus*

The campus is very much pedestrian-friendly and enables access to everyone. It constitute shaded continuous pathways of uniform width and height and obstacle-free to provide better pedestrian accessibility, comfort and safety.

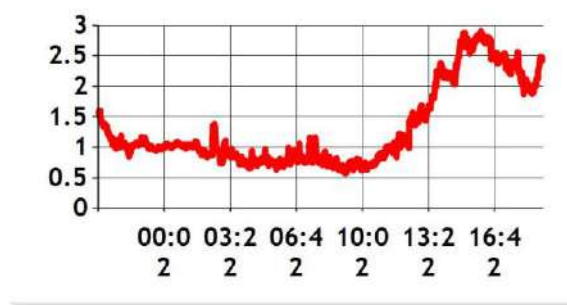
<p>% TOTAL VOLTAGE HARMONIC  DISTORTION VARIATION TIME PLOT  OF CH1  Max Val. : 2.9  Avg. Val. : 1.32  Min Val. : 0.58</p>

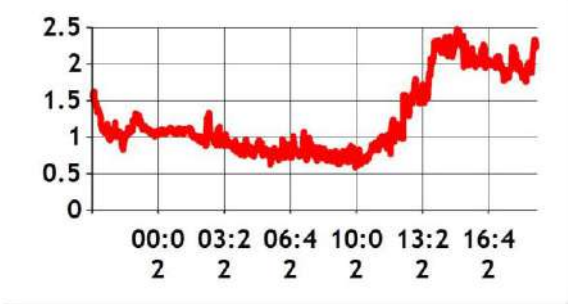
<p>% TOTAL VOLTAGE HARMONIC  DISTORTION VARIATION TIME PLOT  OF CH2  Max Val. : 2.47  Avg. Val. : 1.27  Min Val. : 0.59</p>

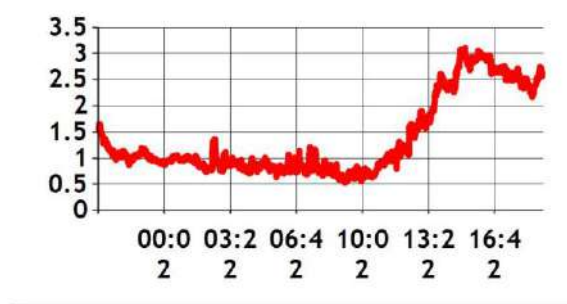
<p>% TOTAL VOLTAGE HARMONIC  DISTORTION VARIATION TIME PLOT  OF CH3  Max Val. : 3.1  Avg. Val. : 1.389  Min Val. : 0.54</p>

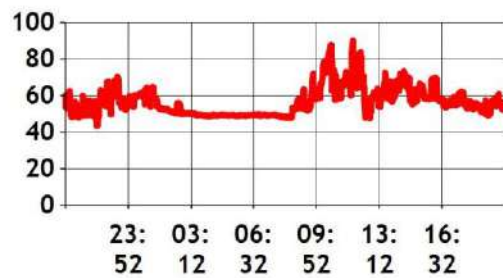
RMS CURRENT VARIATION TIME  
PLOT OF CH1

Max Val. : 89.96 A

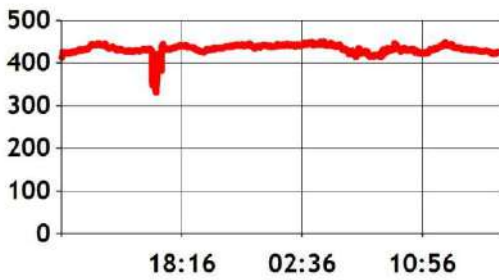
RMS VOLTAGE VARIATION TIME  
PLOT OF CH1

Max Val. : 450.2 V  
Avg. Val. : 432.64 V  
Min Val. : 331.08 V

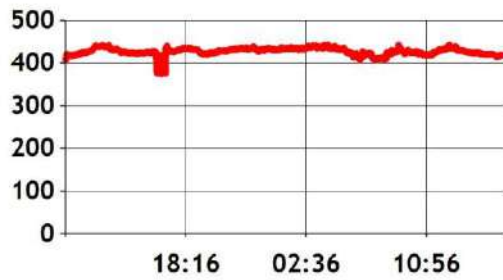
RMS VOLTAGE VARIATION TIME  
PLOT OF CH2

Max Val. : 442.53 V  
Avg. Val. : 426.94 V  
Min Val. : 373.9 V

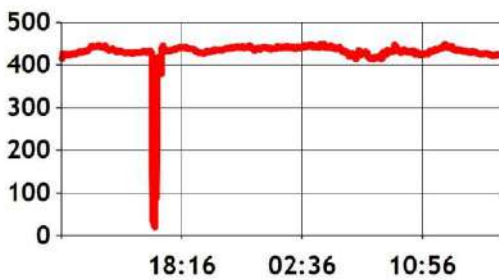
RMS VOLTAGE VARIATION TIME  
PLOT OF CH3

Max Val. : 449.39 V  
Avg. Val. : 429.68 V  
Min Val. : 20.23 V

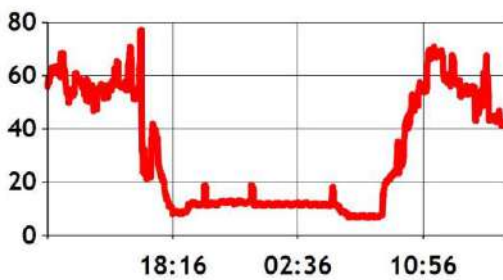
RMS CURRENT VARIATION TIME  
PLOT OF CH1

Max Val. : 77.16 A  
Avg. Val. : 31.7 A  
Min Val. : 6.87 A

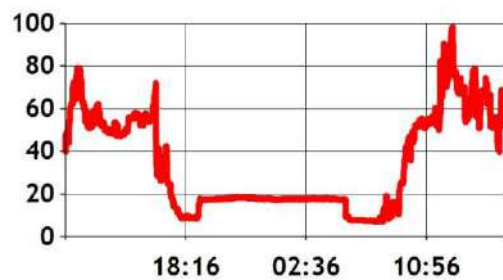
RMS CURRENT VARIATION TIME  
PLOT OF CH3

Max Val. : 98.19 A  
Avg. Val. : 34.46 A  
Min Val. : 7.2 A

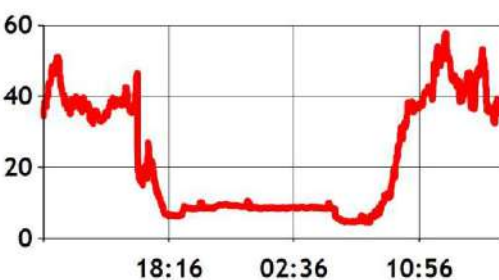
<p>TOTAL ACTIVE POWER VARIATION TIME PLOT</p> <p>Max Val. : 57.83 KW</p> <p>Avg. Val. : 22.66 KW</p> <p>Min Val. : 4.53 KW</p>	<p>TOTAL REACTIVE POWER VARIATION TIME PLOT</p> <p>Max Val. : 14.78 KVAR</p> <p>Avg. Val. : 5.81 KVAR</p> <p>Min Val. : 0.95 KVAR</p>

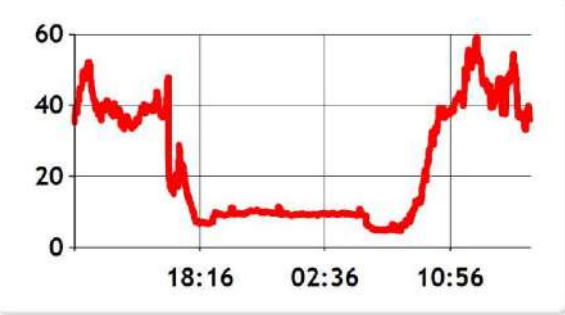
<p>TOTAL APPARENT POWER VARIATION TIME PLOT</p> <p>Max Val. : 59.2 KVA</p> <p>Avg. Val. : 23.48 KVA</p> <p>Min Val. : 4.68 KVA</p>	<p>POWER FACTOR VARIATION TIME PLOT</p> <p>Max Val. : 1</p> <p>Avg. Val. : 0.95</p> <p>Min Val. : 0.85</p>
