GREEN AUDIT REPORT

2020-2021

Dr. Vithalrao Vikhe Patil College of Engineering,
Ahmednagar

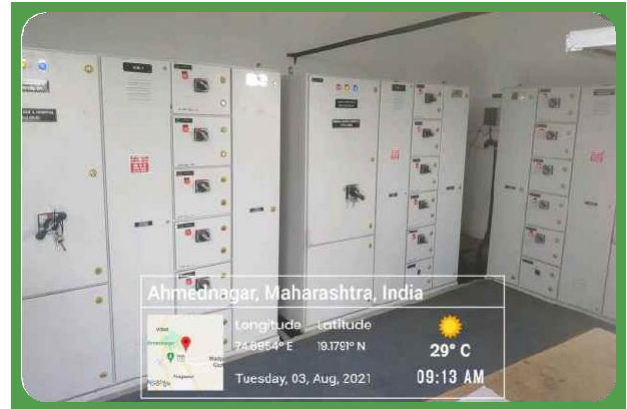
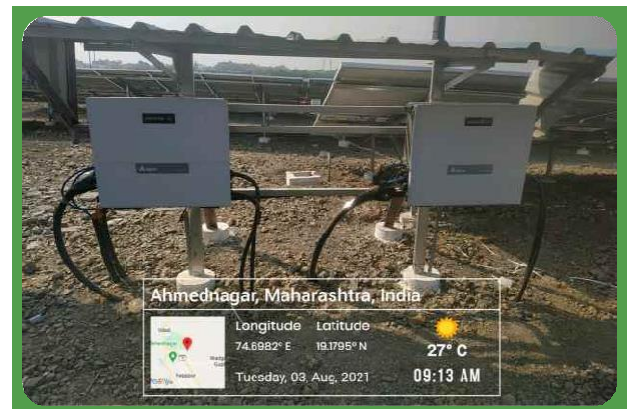
Figure 2: Solar Plant

The captive solar generation plant is capable of generating annually 4,59,000 Kwh units which caterers for Ninety-five percent (95%) of our annual consumption. The plant is state of the art IoT enabled generation plant giving real time generation and fault status on line.

Solar Generation Plant Aerial Photo of Solar Plant

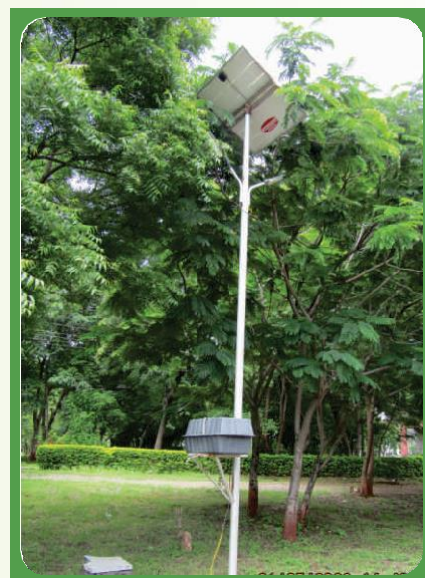
Figure 6 : Solar powered street lights

The project has solar powered street lights installed in the campus. This is a very good initiative towards adoption of clean energy.

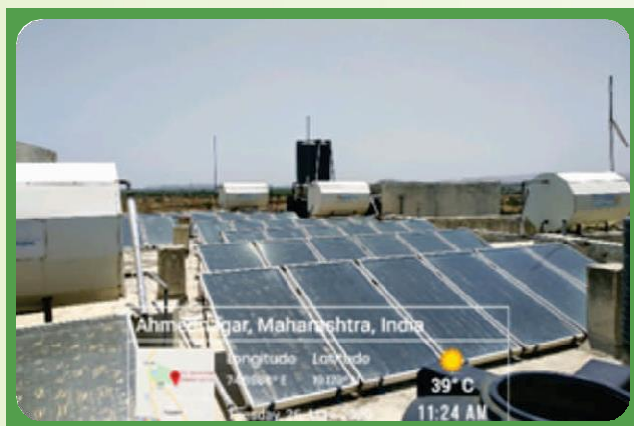
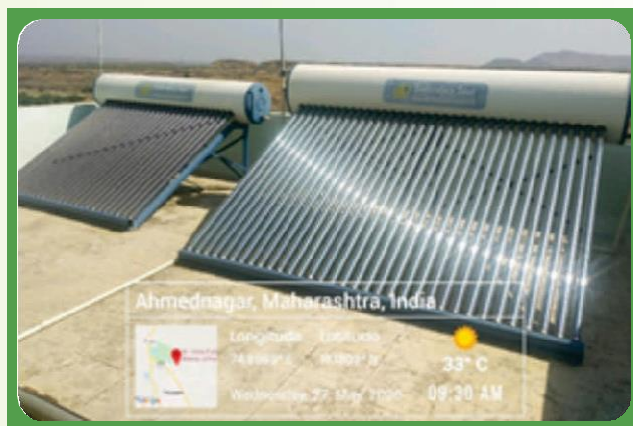
Figure 7 : ETC and FPC solar water heating system

<i>Solar Water Heating Provisions in the campus</i>	
Building	Solar water heating provision (LPD)
Kaveri Hostel	3000
Hostel A	2000
Hostel B	2000
Staff quarters	1000

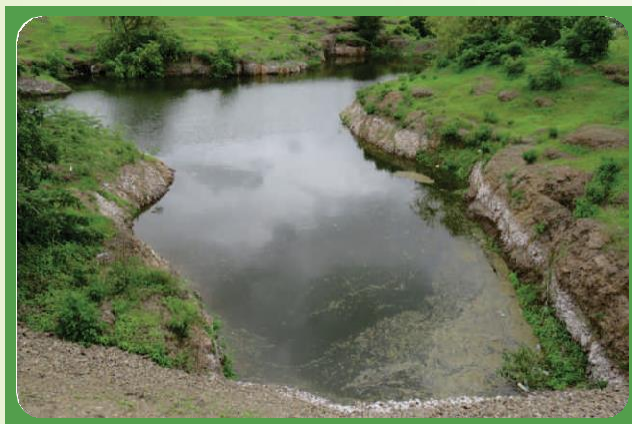
Figure 8 : Check Dam No. 1

The rainwater from roof tops and paved areas are conveyed to check dams through storm water drains. Check dams are located as per contours at intervals. The water in the check dams percolates and helps in increasing ground water levels. The natural water flows and slopes on site are maintained.

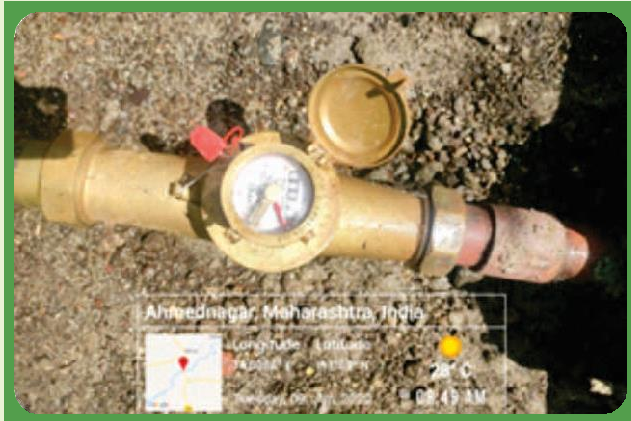
Figure 17 : Water meters installed in campus

Water metering ensures measurement of water consumption for various water use applications. Building level water meters provide total water consumption whereas if sub meters are installed for applications such as treated water reuse for landscape irrigation, flushing, and domestic water can be measured and monitored. The project has installed source level water meters.

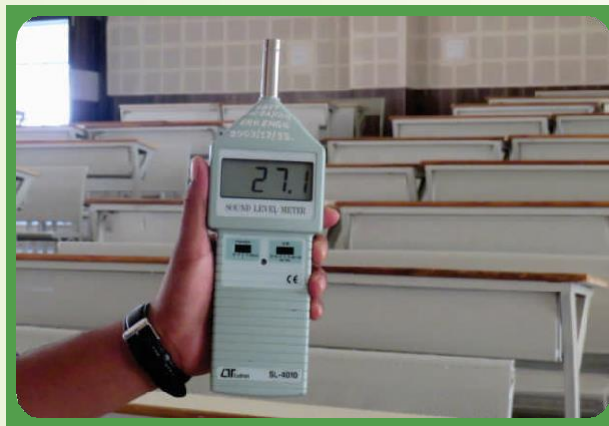
Figure 41 : Noise level measurement

For the project, a decibel meter is used to measure noise levels in different areas within the campus wherein it ranges from 38 dB to 69 dB. It has been found that as the campus is full of green cover and landscaped areas, only the area abutting the highway has higher noise levels. The landscape acts as a noise buffer which keeps the noise at lower levels.

6. It is recommended to conduct air quality and noise monitoring as per recommended protocols by Central Pollution Control Board (CPCB).
7. Exhibit posters / signages / green practice guidelines in strategic locations within campus to educate and spread awareness about implemented green campus initiatives to the occupants and visitors.

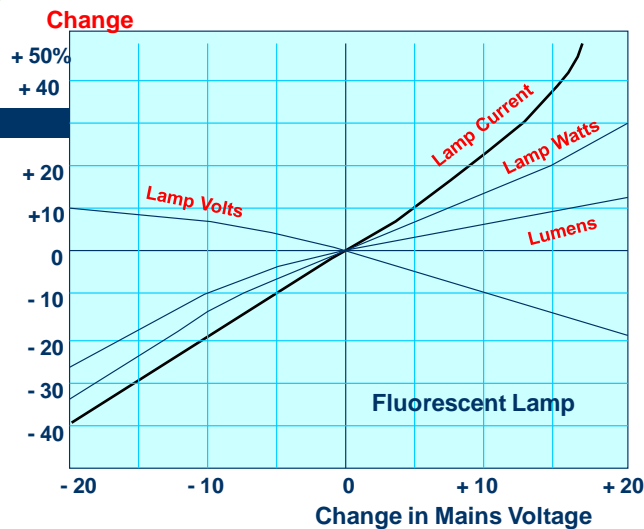
EFFECT OF VOLTAGE ON POWER CONSUMPTION OF LAMPS

RMS voltage variation is on Higher side and increases to 450 Volts .Higher RMS voltage results into increase in power consumption of pumps and lamps in addition to accelerated ageing of Equipments leading to premature failure .Recommended to maintain RMS Voltage near 400V .Present transformer is of 250KVA 11KV/0.433KV , Dyn11 , ONAN transformer and it is not possible to maintain RMS voltage within recommended limit .Recommended to replace existing transformer by New transformer with 250KVA , 11KV/0.415KV , ONAN , Dyn11, with OLTC +RTCC +AVR as per provided specifications

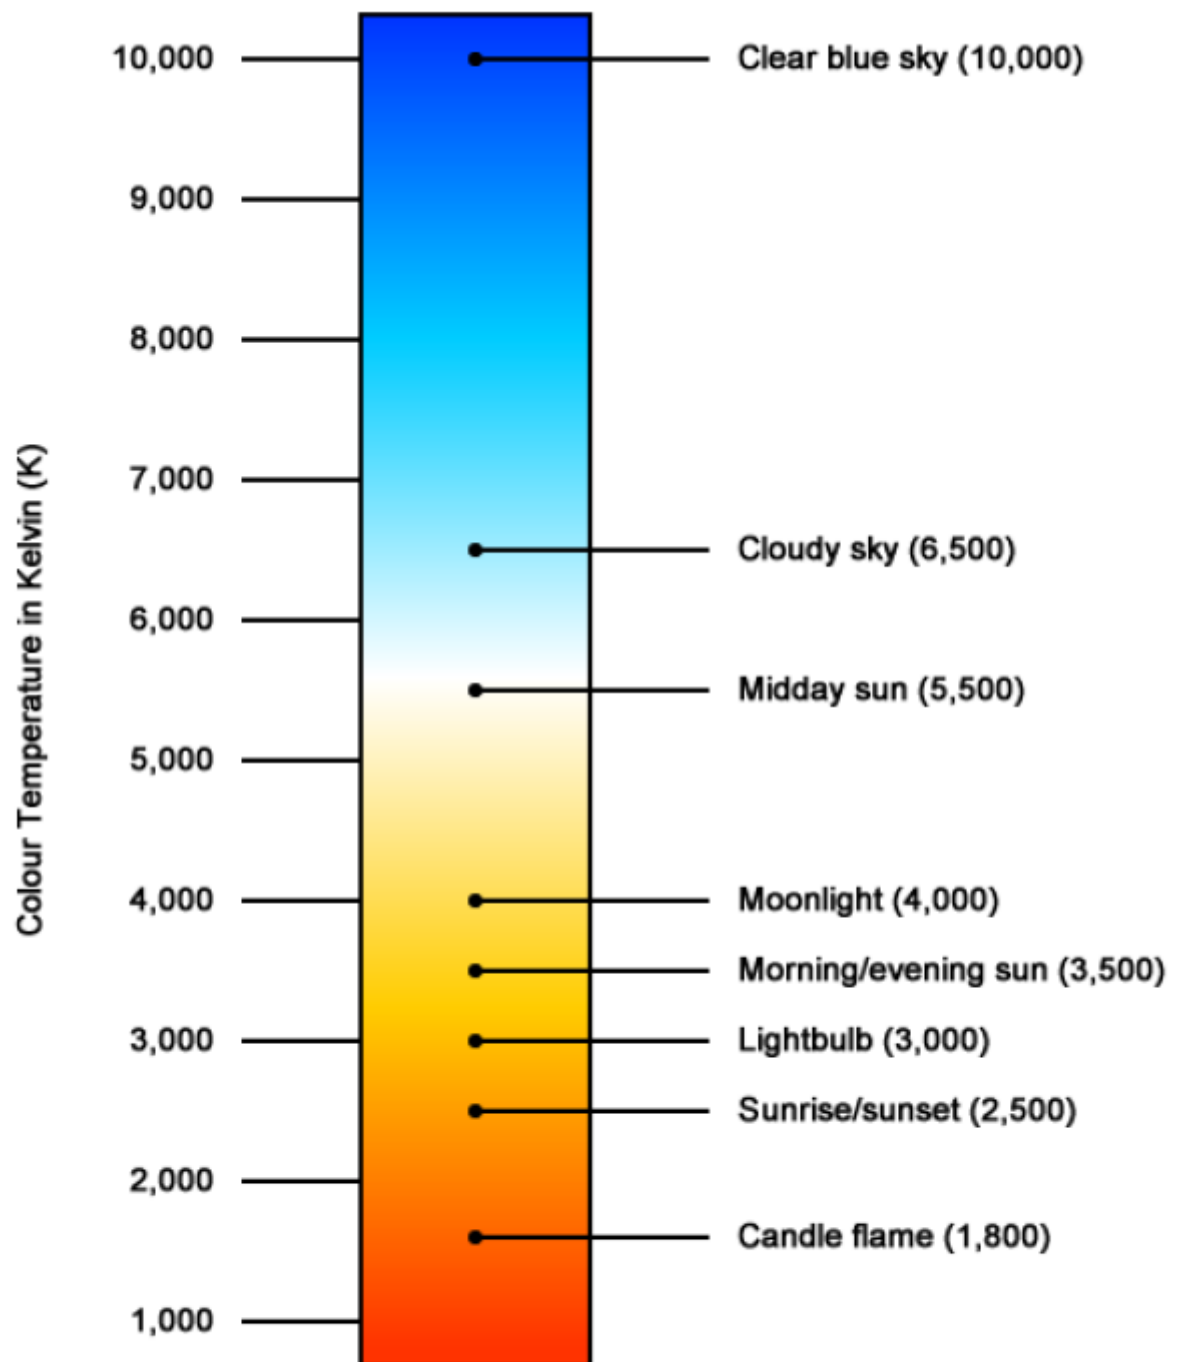
Figure 1 – Correlated Color Temperature Chart

Correlated Color Temperature (CCT) :The correlated color temperature is the absolute temperature (in °K) of a blackbody whose chromaticity most nearly resembles that of the light source. Lamps with a CCT rating below 3200°K are usually considered warm sources, whereas those with a CCT above 4000°K are usually considered cool in appearance. Temperatures in between are considered neutral in appearance. Warm lights are usually used for indoor application whereas cool light is used for outdoors and industrial application. Figure 1 shows the CCT of various light sources.
